# New Hampshire Volunteer Lake Assessment Program

## 2003 Interim Report for Forest Lake Whitefield

## Forest Lake, Whitefield

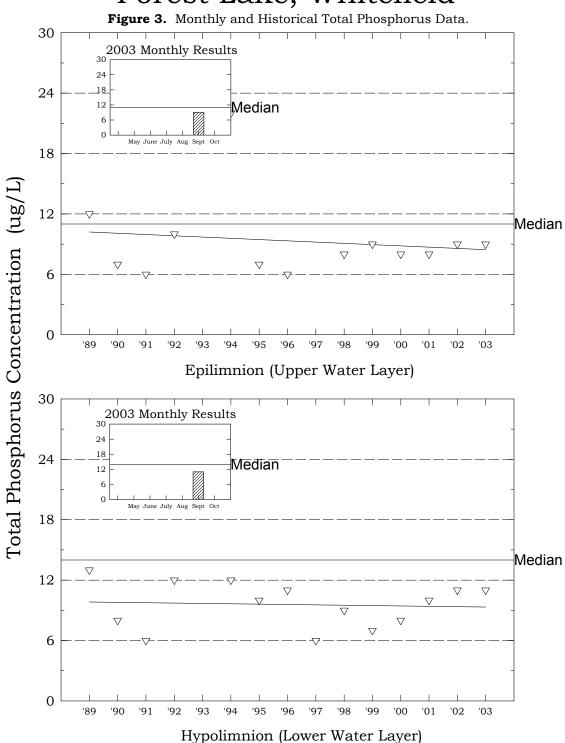
Figure 3 and Table 8: The graphs in Figure 3 (Appendix A) show the amounts of phosphorus in the epilimnion (the upper layer) and the hypolimnion (the lower layer); the inset graphs show current year data. Table 8 (Appendix B) lists the annual maximum, minimum, and median concentration for each deep spot layer and each tributary since the lake has joined the program.

The current year data for the epilimnion (the top inset graph) and the hypolimnion (the bottom inset graph) show that the phosphorus concentration in September was **slightly less than** the state median.

Overall, visual inspection of the historical data trend line for the epilimnion and the hypolimnion show a *variable* phosphorus trend. Specifically, this means that the phosphorus concentration has *fluctuated*, but has not *continually increased* or *continually decreased*, since monitoring began.

One of the most important approaches to reducing phosphorus loading to a waterbody is to continually educate watershed residents

about its sources and how excessive amounts can adversely impact the ecology and value of lakes and ponds. Phosphorus sources within a lake or pond's watershed typically include septic systems, animal waste, lawn fertilizer, road and construction erosion, and natural wetlands.
